CEE 3000, Section C  
April 24, 2014  
Group 5

# A Systems Analysis of the Restoration Project on the Acropolis

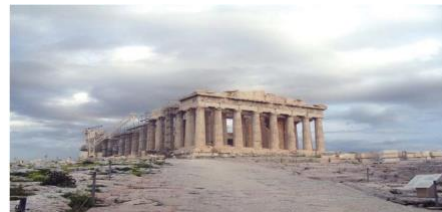
**Figure 1:** The Parthenon

The Parthenon is a temple of the Doric order. The Parthenon is located within the southern-central area of the Acropolis hilltop. The entrance and rear to the Parthenon is equipped with eight columns while the sides have seventeen, and all 46 columns conform to a ratio of 9:4. This ratio was used to determine the vertical and horizontal proportions of the temple as well as other characteristics of the structure. The dimensions of the base of the Parthenon are, measured from the front step, approximately 69.5 meters long by 30.9 meters wide. The inner chamber of the Parthenon, known as the cella, was 29.8 meters long by 19.2 meters wide. The Doric order columns on the exterior are 10.4 meters high and 1.9 meters in diameter (Meletzis and Papdakis, 2005). The Frieze of the Parthenon is 1 m tall, and wraps around the entirety of the structure. Marble blocks have been removed from all over the Parthenon for various reasons. Some of these blocks have been cleaned using laser technology, and some replaced by new, quarried marble, which has been recreated to meet the specifications of the old pieces (Petropoulou, 2008). The current state of the Parthenon is depicted in Figure 1 to the right.

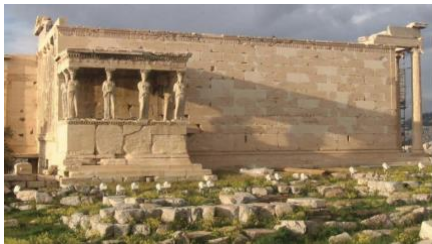
**Figure 4: Erechtheion, South Wall**

The Erechtheion, where construction on it started in 420 BC, is located just north of the Parthenon within the Acropolis hilltop. The purpose of the Erechtheion was to house religious rituals that the old temple conducted. The style of the Erechtheion was ionic. A unique feature of the Temple is the six Caryatids that support the porch of the temple. Caryatids are figures of women sculpted into a column-like structure that replace the functional characteristics of a column. Different areas of the Erechtheion are dedicated to different deities, such as Athena and Poseidon. Restoration attempts on the Erechtheion began in 1977 and concluded in 1988. Much of the restoration involved removing, cleaning and then re-adding replicas of the Caryatid support columns and marble blocks that serve as the foundation. The result of these efforts is depicted in Figures 4 and 5 (below). The British hold one of the original support columns in London’s British Museum, and the Greeks hold the other five in their New Acropolis Museum. Replicas are currently in place at the Acropolis Hill (Kaltsas, 2002). Figure 6 (below) depicts a recreated caryatid support column.

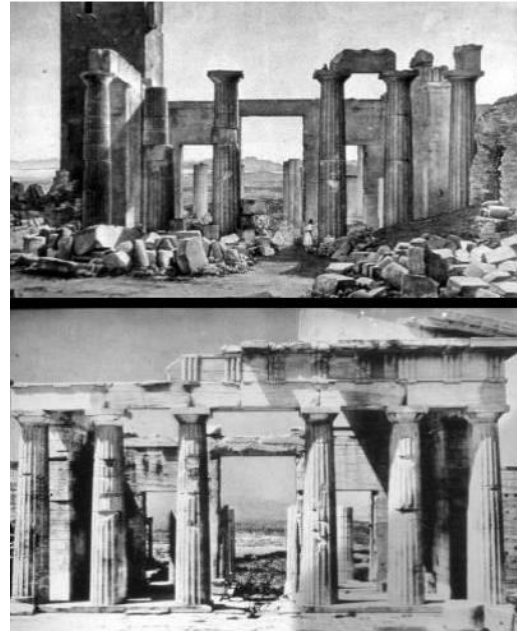
Below, figure 7 depicts Balanos' restoration of the Propylaia's east side before (above) and after (below). After Balanos passed away, only one other restoration went underway until modern times. The other major player in the restoration was Anastasios Orlandos, where his team only focused on restoration of the Propylaia from 1947 until its conclusion in 1957 (Economakis, 1995). Balanos attempted to reconstruct the temple by anchoring and connecting adjacent marble pieces together with iron clamps. Many of these initiatives to reestablish the Parthenon have caused more damage than production, altering the original integrity and structure of the Greek Temple. Although his efforts appeared to be productive, his poorly executed process of assembling connection pieces was destructive to the material. The rusting and consequent expansion of iron elements caused cracks in the marble and enhanced other occurrences of decay, which impacted a large measure of the Parthenon (Lenke, 2014).

**Figure 7:** Propylaia east side before and after the restoration of Balanos

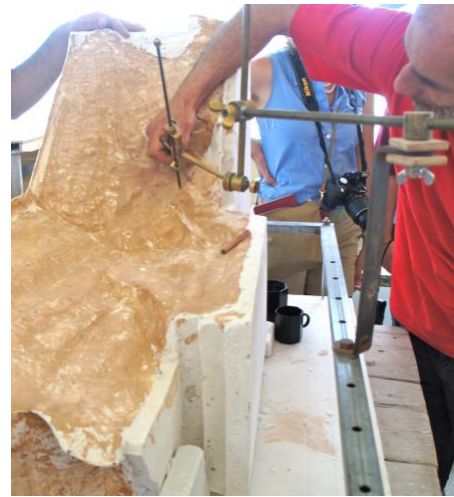
The workers today use the same techniques and tools that were used in ancient times, including a pantograph (as seen in figure 8 below) that is used to shape a new 3D cast to the missing portion of each piece. Although each block has roughly the same shape as its original, there are slight irregularities, which can be positioned and matched up by their connection pieces and their push direction. The initial irregularities were driven by the original architecture of the temple. Iktinos and Kallikrates designed the structure to have a natural curve to it. Basically, there are no straight lines on the Parthenon, forming an optical illusion to the visitors of the Acropolis. If the temple had completely flat surfaces and straight lines, there would be a bowing-up of the edges, making the temple look unapproachable. The architects designed the temple to have the opposite bend in the straight lines to negate the optical illusion, as seen in figure 9 below (Lenke, 2014).

**Figure 8:** Worker using a pantograph on a marble member

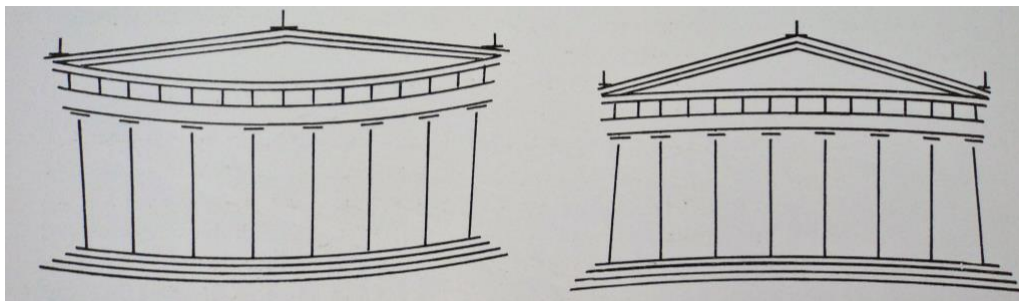
**Figure 9:** A depiction of the illusion to the eye after approaching a tall straight surface (left) to a curved surface (right)

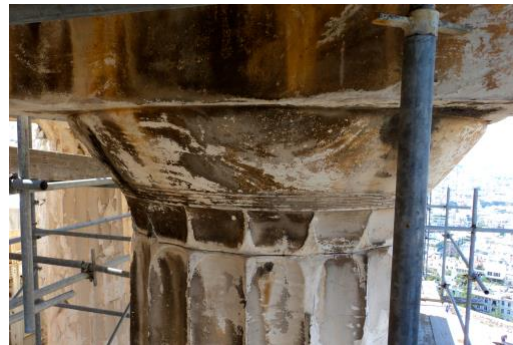
One of the most current issues at hand with the Parthenon and its surrounding monuments are the current structural forms of the cella wall blocks that are difficult to replace. The main problems with the age of the Parthenon are the gradual increases in pollution and acidic rain over the past 30 years and the intense seismic area of the Acropolis in which the current restoration project is taking place. The cella walls and the rest of the temple are heavy pieces of marble that consist of rows of rectangular blocks, all with the same height. One cornice block weighs approximately 4 tons with over 30 cornice blocks per short side. With the massive weight to everything on the Parthenon, it makes it difficult to move pieces back and forth by crane. The main issue of the cella walls, and really the whole temple, is that Greece is a very seismic area. Men cannot move 4-ton blocks of marble, but the earth movements can. As a result of too much carbon monoxide from pollution, acidic rain has affected the monuments more in the past 30 years than in the last 24 centuries. The condition of the black soot on the marble seen in figure 10, created by the pollution of carbon monoxide, cannot be scraped off because it will jeopardize the surface of the marble. This is seen in figure 5 to the right. Many of the conservationists in the Acropolis Museum and researchers from Crete have been using a cleaning method with lasers to clear the black soot off of the triglyphs, metopes and the Caryatid columns from the Erechtheion (Lenke, 2014).

**Figure 10:** Soot buildup on marble surfaces from carbon monoxide

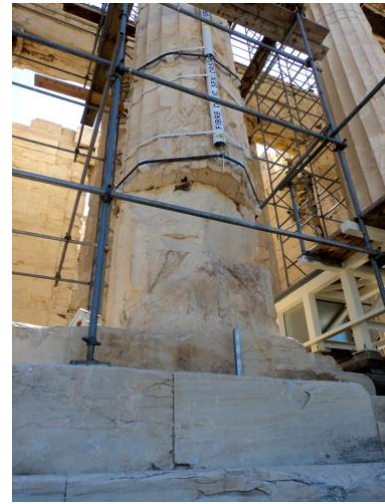
Acropolis Hill is a block of Late Cretaceous grey limestone. The structures of the Acropolis are built of marble stones in the form of blocks or drums without mortar, connected together in precision by dry masonry. The Acropolis is centered on a hotspot of seismic activity, which in return has caused severe marble cracking in specific portions of the Parthenon. The locations of these seismic actions are the southwest corner of the Parthenon, the West side of the Parthenon, and the south wall of the Propylaea. According to the Director Emerita of the YSMA, Maria Iannidou, a total of 10 accelerographs have been installed from the Geodynamic Institute of the National Observatory in Athens between 2008 and 2013. The purposes of these accelerographs, seen in figure 11, are to record and monitor the seismic activity of the Parthenon on the Acropolis and the shifting movement of the resting marbles seen in figure (Ioannidou, 2013).

**Figure 11:** An accelerograph attached to a shifted column

Now, the accelerographs and titanium clamps replaced the older forms of restoration (Ioannidou, 2013). The marble masons only use environmentally friendly tools that include basic hammer and chisel techniques to avoid any environmental issues. It also keeps the idea of classical construction alive (Lenke, 2014). The only issues with these solutions are time and money. In both cases, it takes too many resources to achieve the intended job. The issue of money and time cycles back to the issue of previous data extractions on whether or not more money should or should not be implemented and spent on the restoration.

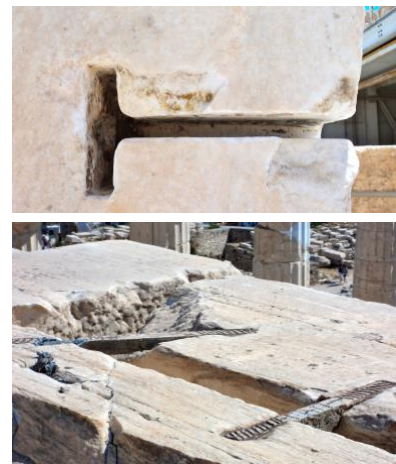
Another issue that has developed over the past several decades is the accumulation of sulfur dioxide and carbon monoxide settled on and in the calcium marble. There has also been an accumulation of erosion seen in figure 12 within the marble due to the iron clamp anchors that initially supported the seismic movement under Balanos' team. The present restoration teams have taken actions to intervene and restore the marble to its initial state. Actions on the accumulation of sulfur dioxide and carbon monoxide on marble members include laser treatment and scraping of the soot from the marble. A step process of filling in missing marble pieces with new marble pieces and replacing the old, eroded iron clamps with titanium clamps is a modern practice.

**Figure 12:** Oxidized marble members and iron clamps
